Assessment Report for
Pennsylvania, 420600

Visit date: November 6, 2003

A visit was made to the Pennsylvania SPS 6 site on November 6th, 2003 for the purposes of conducting an assessment of the WIM system located on US Interstate 80 at milepost 151. This site is currently not a candidate for a field performance evaluation and calibration.

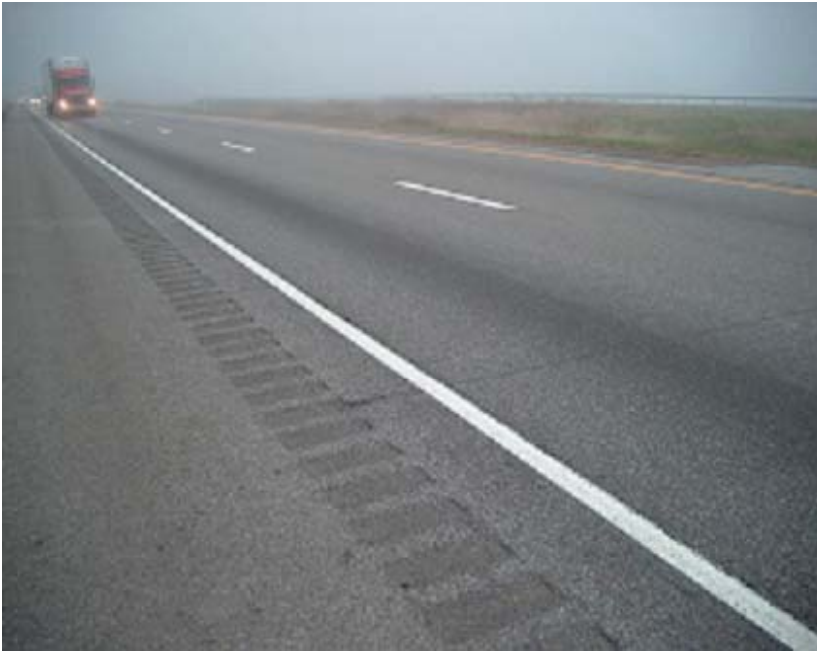
Figure 13-1 Pavement Condition of Pennsylvania 420600

Based on visual survey the pavement condition is generally good except for a transverse dip in the pavement approximately 161 feet before the leading WIM sensor, low severity rutting in the wheel path and medium severity longitudinal cracking at the edge of the pavement and shoulder. The distresses noted are not significantly affecting the movement of the trucks. It is the roughness condition that is leading to the pavement remediation recommendation.

The pavement conditions at this site have been adversely affected by numerous sensor replacements/relocations as well as the transverse dip noted prior to the WIM sensor location. At a minimum, the asphalt pavement overlay should be rehabilitated or replaced throughout the WIM scale area. In accordance with FHWA LTPP WIM standards, it is recommended that the pavement be replaced with new Portland Cement Concrete from 425 feet prior to the WIM area to 75 following the WIM sensor location.

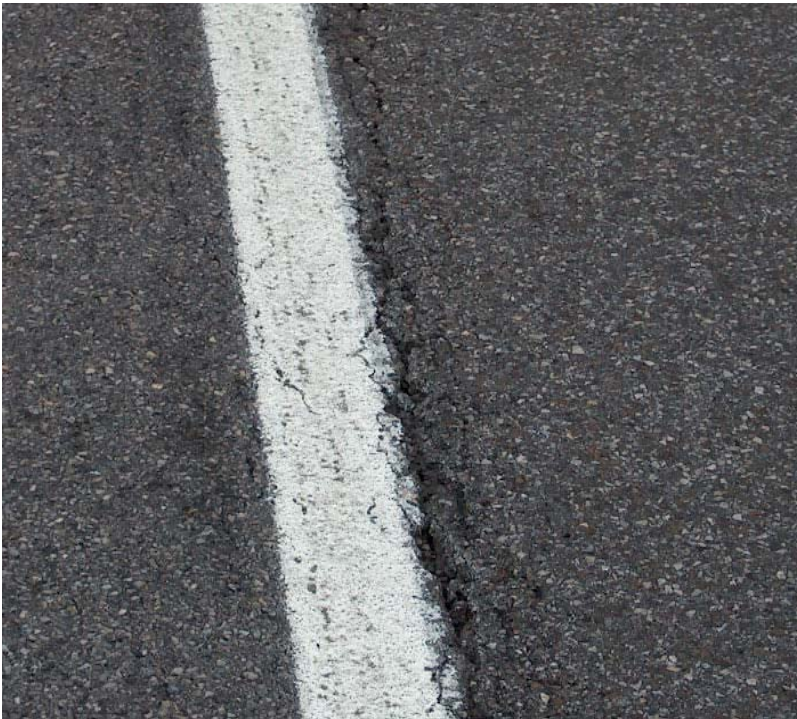
Figure 13-2 Longitudinal Cracking in pavement of Pennsylvania 420600

Figure 13-1 shows the overall condition of the pavement, Figure 13-2 shows the environmental cracking.

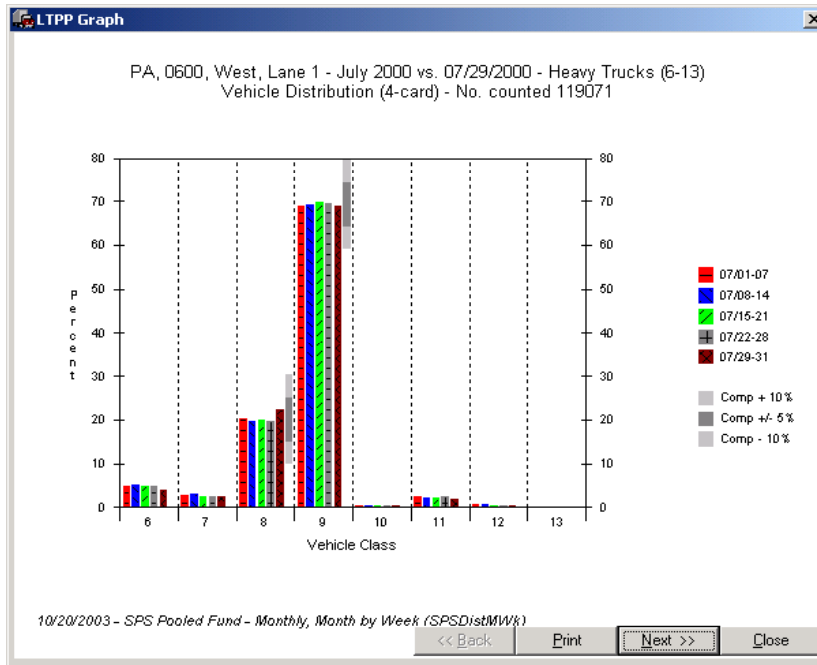
Figure 14-1 Typical Heavy Truck Distribution Pattern for Classification Data at 420600

Figure 14-1 shows a typical by week pattern for classification data. The individual weeks show essentially the same mix to the fleet. Every vehicle in Classes 6 through 13 that constitutes at least 10 percent of the population is expected to stay within plus or minus 5 percent of the value observed during the two weeks following calibration. This range is shown by the darker band inside the lighter band to the right of the weekly data. Weeks that go outside more than plus or minus 10 percent of the expected value will fall above or below the light gray areas of the band. These are weeks that should have been subjected to additional scrutiny prior to accepting the data as reasonable. For this site, the fleet mix is comparatively stable between January 2000 and July 2001. However, after July 2001 there is a sudden decrease in Class 8 vehicles and a minor increase in Class 11 vehicles. A typical graph for this period is shown in Figure 14-2. This is similar to the distribution in the 1993 and 1995 data. It may represent a true shift or ghost axles from a temperature sensitive sensor may have added axles. The reason cannot be determined at this point in time. Figure 14-3 shows the typical pattern for vehicle distribution by month by year for the data collected from the classifier versus the data collected by the WIM equipment. The data collected in the months of March, July, August and September of the year 2000 by both classifier and WIM equipment appear to be similar except for the month of July where classifier data is significantly higher than the WIM equipment data. The pattern observed in the weekly graphs is also present in the available 2001 data.

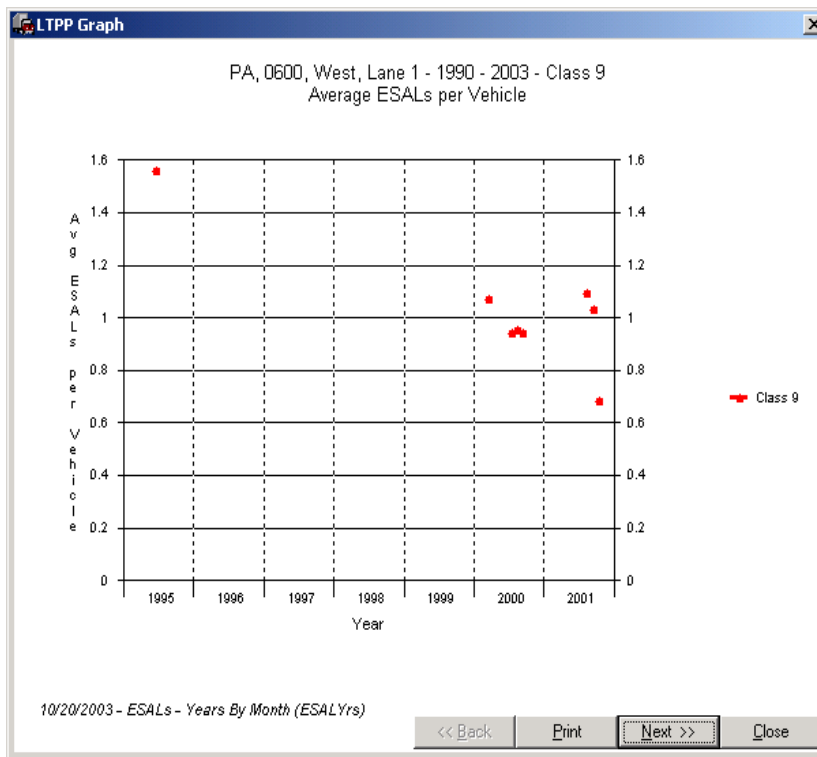
Figure 14-4 Average Class 9 ESALs for site from 1995 to 2001 for 420600

Average ESALs for Class 9 vehicles are a very crude method of identifying loading shifts. Figure 14-4 shows the average Class 9 ESALs per month for this location. To remove the influence of changing pavement structure all ESAL values have been computed with and SN = 5 and a p_t of 2.5. Average ESALs per Class 9 are not used as an indicator of research quality data.

In the years 2000 and 2001 the ESALs per year appear to be similar. However, the ESALs per year for 1995 appear to be significantly different from the years 2000 and 2001.

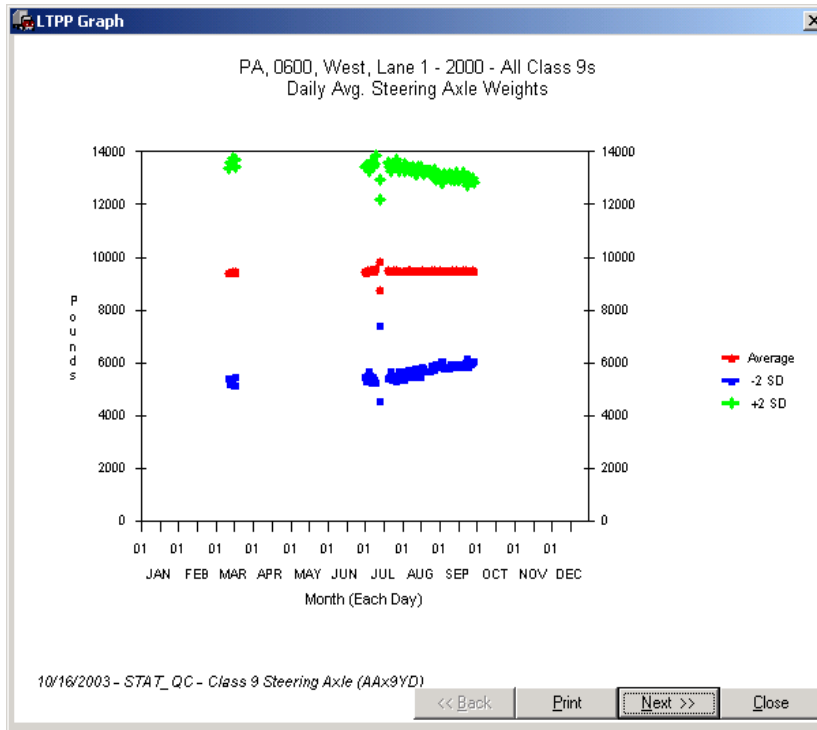
Figure 14-5 Average Daily Class 9 Steering Axle Weight - 2000 – 420600

A frequently used statistic for checking scale calibration and doing auto-calibration of WIM equipment is the weight of the front axle. This value is site specific and should be relatively constant particularly for loaded Class 9s (vehicles in excess of 60,000 lbs.). Typically when auto-calibration is used this value either cycles repeatedly or with very large truck volumes results in an essentially straight line for the mean. As shown in Figure 14-5, the weight of the front axle was essentially constant in the months when data was collected. Where the 2000 data was slightly less than 10,000 lb, the 2001 data was slightly over 10,000 lb before dropping in mid- September to 8,000 lb by the end of the data collection period

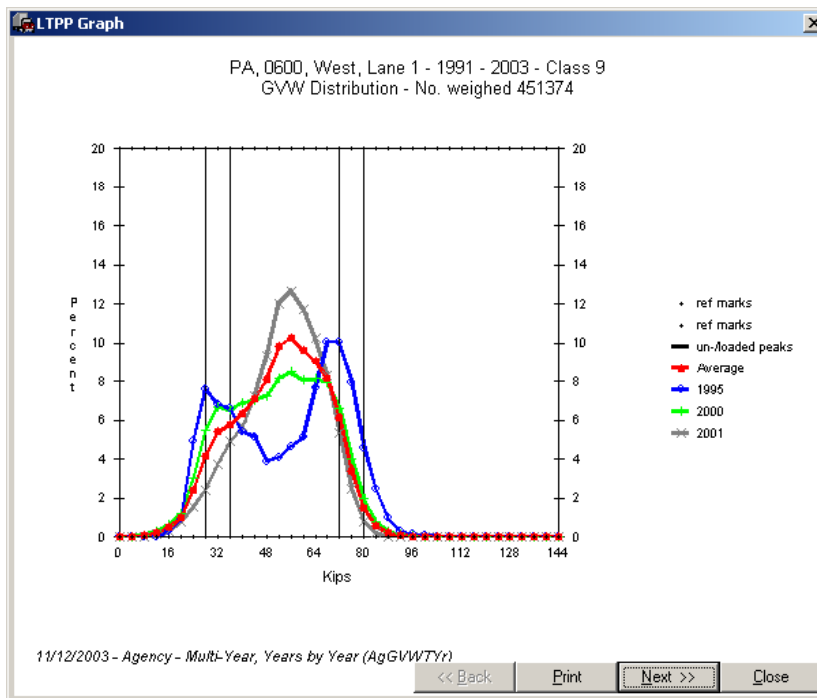
Figure 14-6 Class 9 GVW Distribution over years of available data - 420600

The overall assessment of loading patterns is done using a Class 9 GVW graph by year over the available years. Figure 14-6 shows the shift from the expected bimodal curve to a unimodal curve over time.

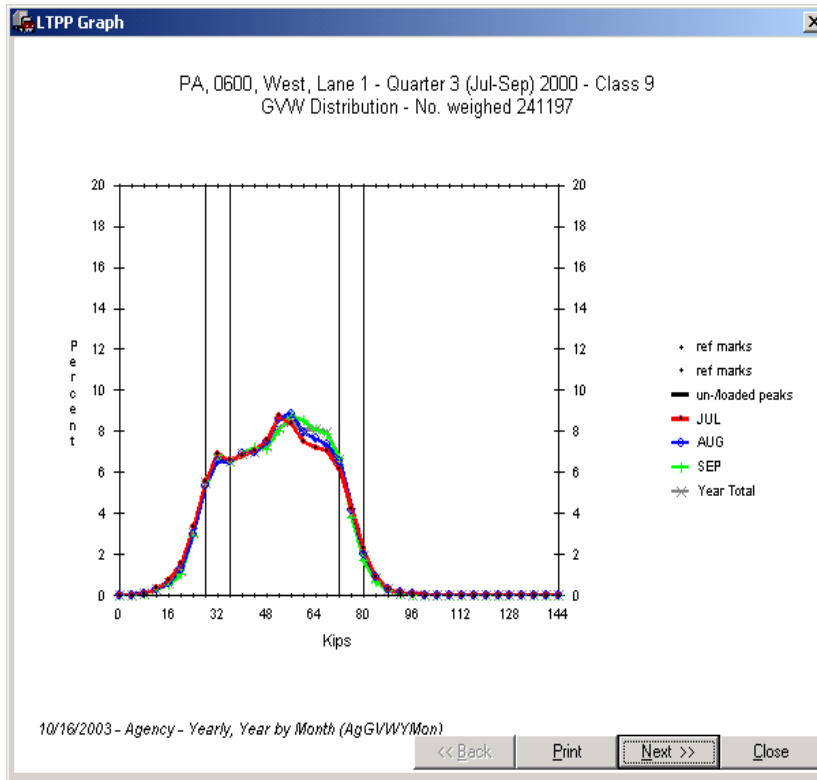
Figure 14-7 Class 9 GVW Distribution – September/2000 to August/2000 – 420600

To investigate any seasonal variations the Class 9 GVW distributions are graphs by month by year. As shown in, there is no significant difference between the three months. This is also an indicator that the unusual annual pattern is not influenced by one or two months.

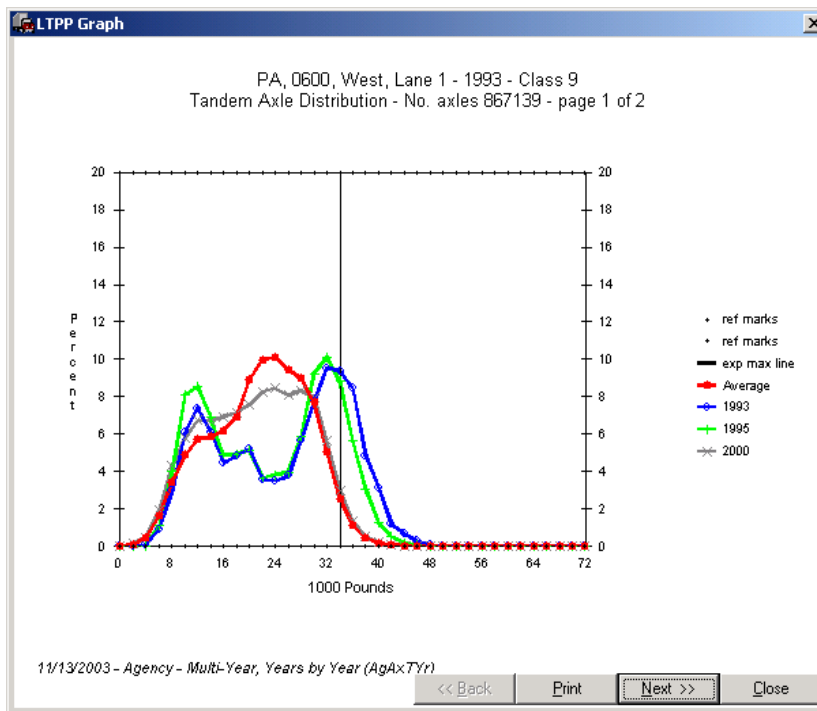
Figure 14-8 Class 9 Axle Distribution – 1993 to 2000 – 420600

GVW graphs were not available for 1993. For all years axle distribution graph for Class 9 vehicles was created to evaluate that loading information. For 1995, a year with a rational pattern, the tandem axle graph was also produced to be used as a reference for 1993 to 2000. As can be seen in Figure 14-8 the pattern for 1993 data is very similar to that for 1995. Thus a 1993 GVW graph for Class 9s would be similar to that for 1995 since the weight of a Class 9 is dominated by its tandem axles.
